PROPERTY INSPECTION REPORT FORM

James Otte	07/16/2024
Name of Client	Date of Inspection
2250 Otte Road , Stonewall, TX 78671	
Address of Inspected Property	
Mike Mullins	21584
Name of Inspector	TREC License #
Name of Sponsor (if applicable)	
TREC License #

Home Inspection Report

PROPERTY INSPECTED:
2250 Otte Road
Stonewall, TX 78671

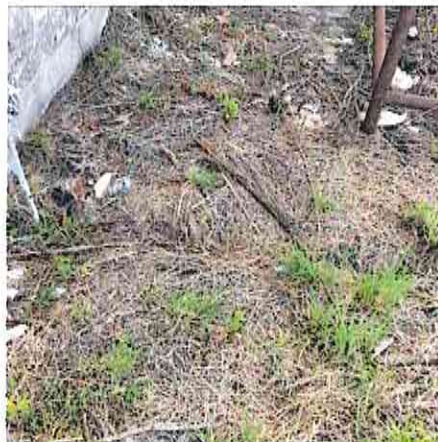
- **Low spots were observed around the foundation. Recommend re-grading to allow water to flow away from the house.**

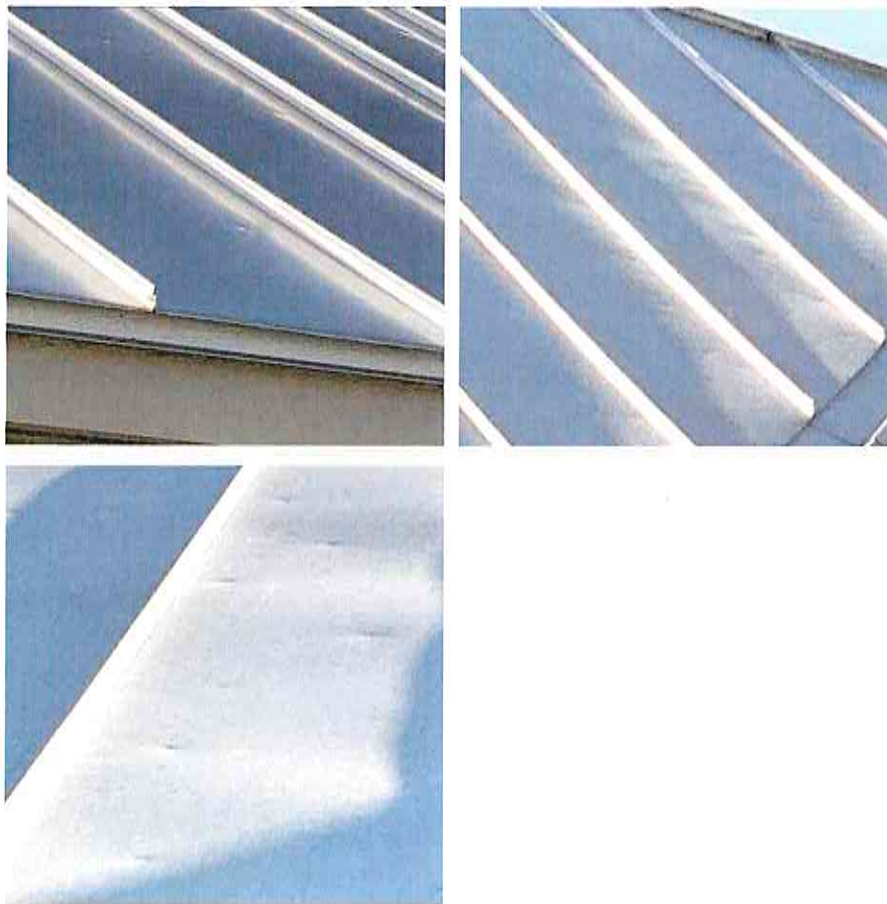
- The appearance of hail damage on the roof covering was observed, which may shorten the life of the shingles.

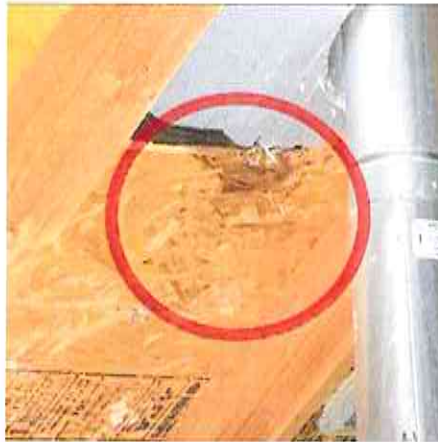
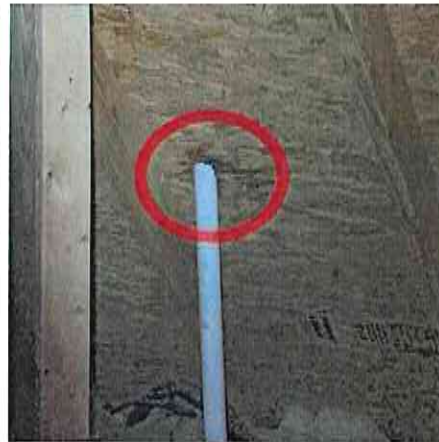
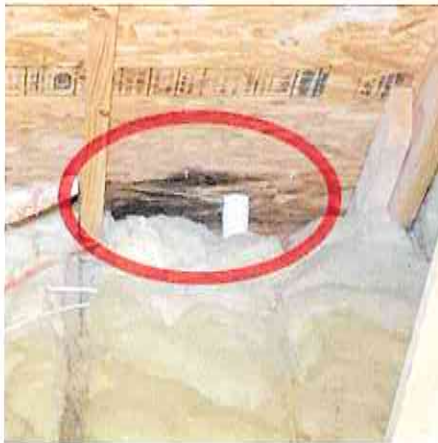
- **Signs of moisture was observed at roof decking when observed from the attic, which may be associated with previous roof leaks.**

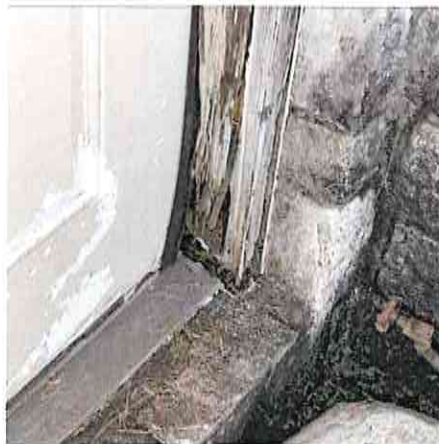
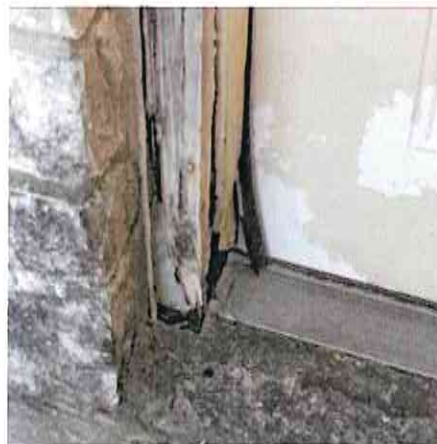
- Rotted siding was observed.

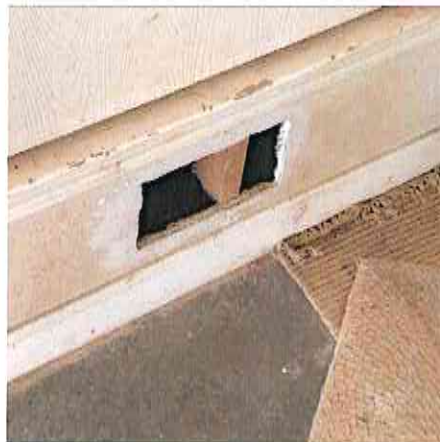
- Proper wall firewall material (sheetrock) was missing in the garage. This is a potential fire safety issue.

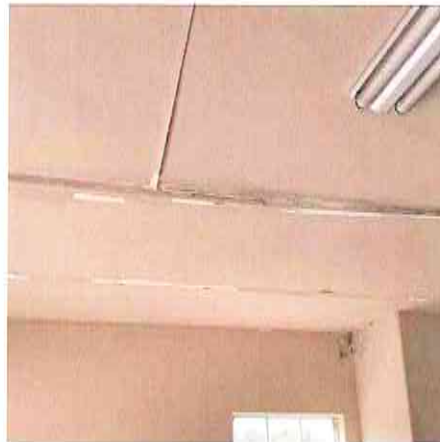
- Damaged ceiling area was observed. (Garage)

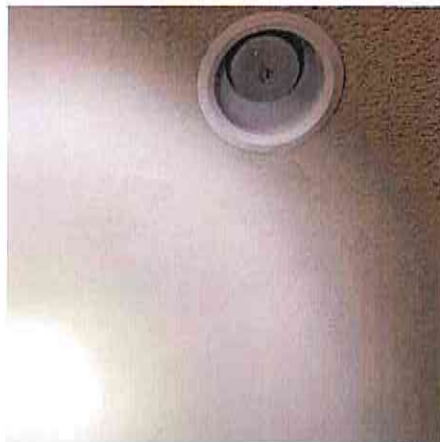
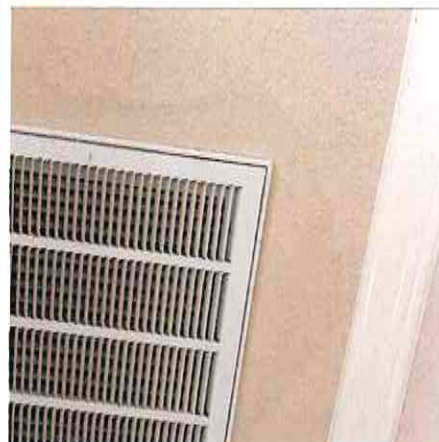
- Signs of moisture was identified at ceiling areas. The inspection couldn't determine the cause or condition of underlying materials.

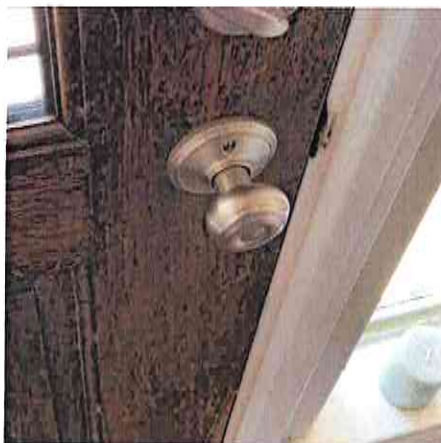
• Door handle was loose.

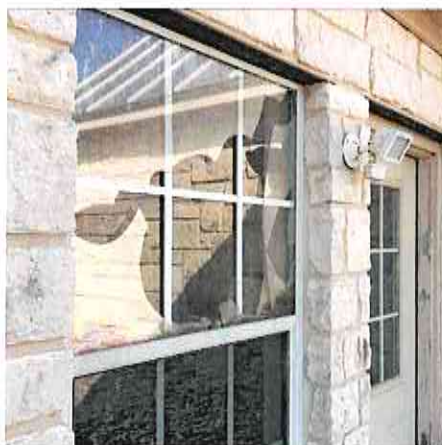
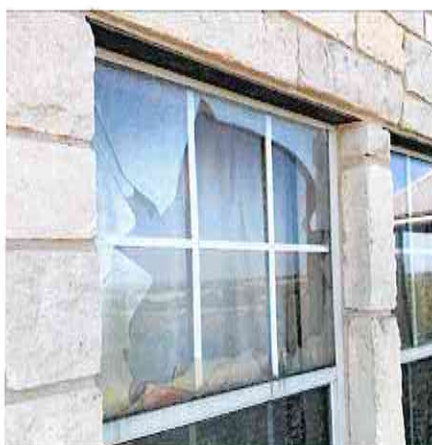
• Broken windows were observed

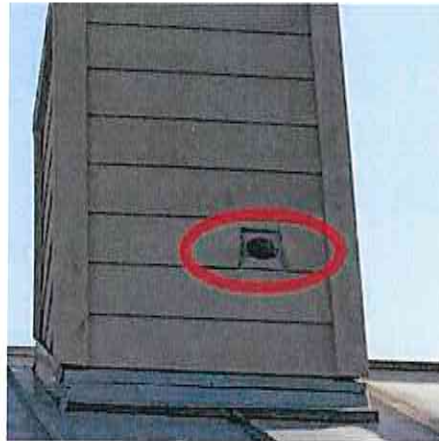
- Note: It is important to note that this is a visual inspection of the fireplace. No fire was lit to test draft nor was any part cleared of the soot/creosote build up to check condition of flue lining or firebox under build-up.
- Exhaust pipe cover was missing.

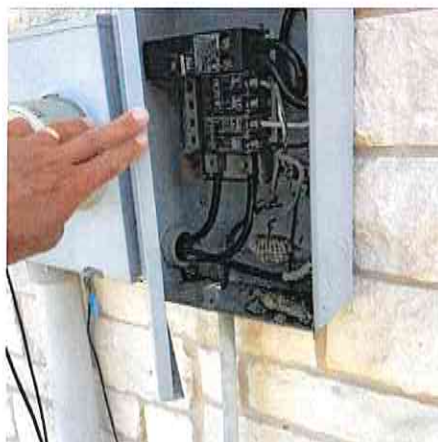
- Exterior electrical panel was missing cover (dead front), which may pose a safety hazard.

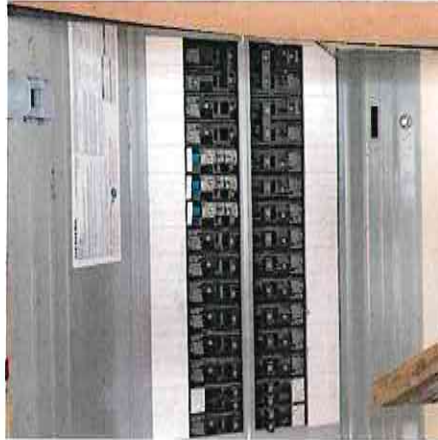
- Arc Fault Circuit Interrupt (AFCI) protection was missing in required locations, which may pose a safety hazard. AFCI protection is required in the following locations: kitchens, family rooms, dining rooms, living rooms, parlors, libraries, dens, bedrooms, sunrooms, recreation rooms, closets, hallways, laundry area.

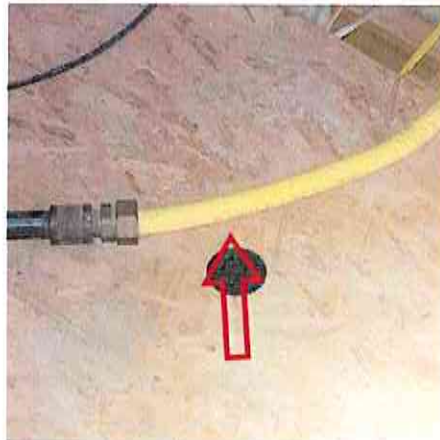
- The Texas Real Estate Commission requires licensed home inspectors to identify and report the presence of corrugated stainless steel tubing (CSST). CSST was observed in the attic. The inspector was unable to determine if the CSST had the proper electrical bonding connection between the gas piping system and the electrical system due to lack of access caused by walls, insulation, etc. The lack of strong electrical bonding may increase the potential for lightning strikes to cause arcing at the CSST gas piping that may result in perforation of the piping, gas leaks, and fires. Recommend a licensed electrician determine if the CSST is properly bonded.

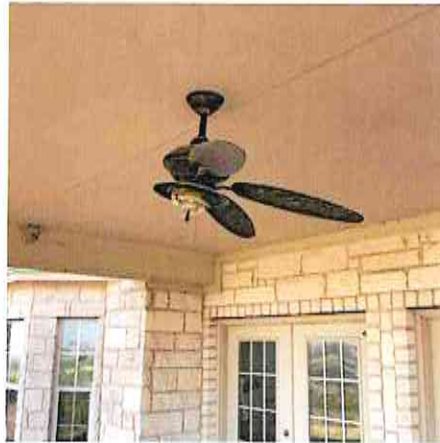
- Smoke detectors were missing in required areas. This is a fire safety hazard. Smoke alarms are required in each sleeping room, outside and in the immediate vicinity of the sleeping rooms (hallway), and at least one on each addition floor.
- Ceiling fan was damaged.

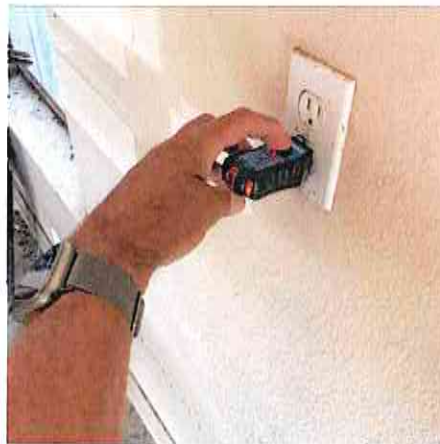
- Outlets in required locations were not GFCI (Ground Fault Interrupt) protected. GFCI protection is required at the kitchen counter tops, bathrooms, exterior, garage & within 6' of a sink. Recommend installing GFCIs to prevent potential shock.

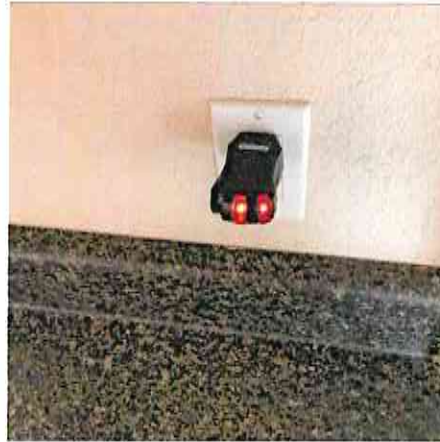
- Receptacle was reverse hot/neutral, which may pose a safety hazard. (Laundry area)

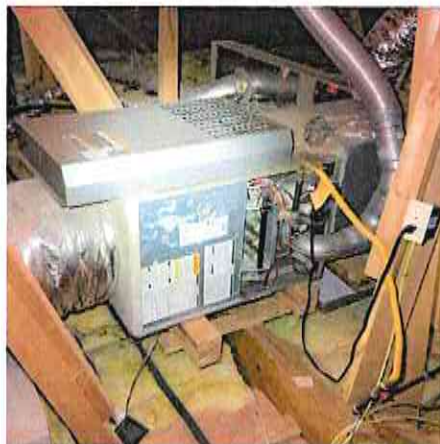
- Cover wasn't installed properly.

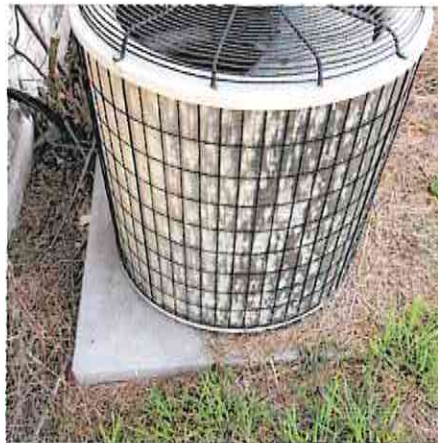
- **Damaged fins were observed, which may affect the cooling process.**

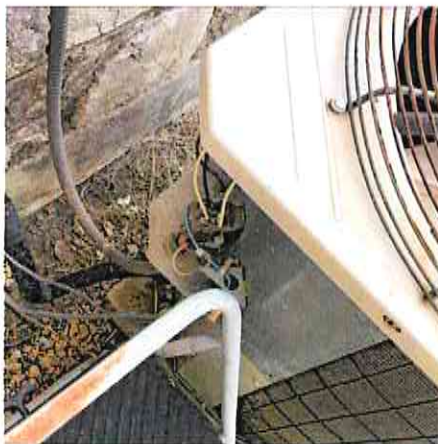
- **Cover wasn't installed properly.**

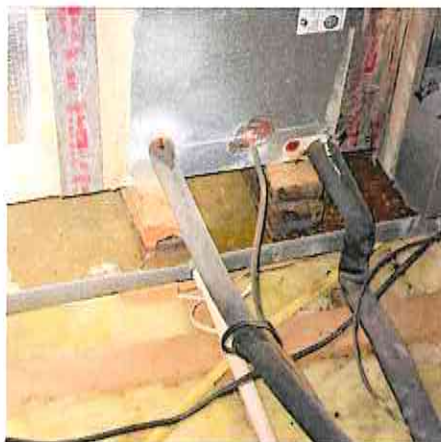
- Signs of moisture was observed at the air handler secondary drain pan. Although active moisture wasn't observed at the time of inspection, this is typically associated with the primary drain being clogged.

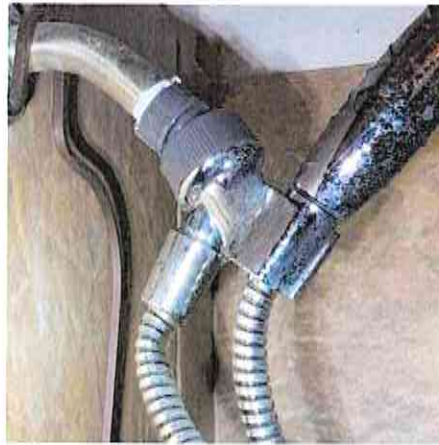
- A water leak was observed at the shower head.

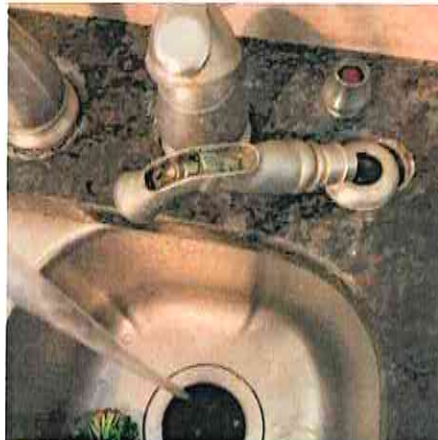
- Sink sprayer didn't work. (Kitchen)

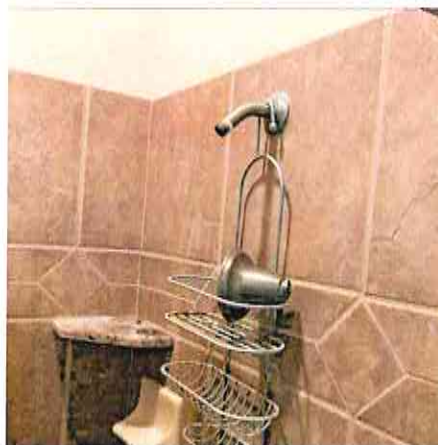
- Showerhead wasn't installed.

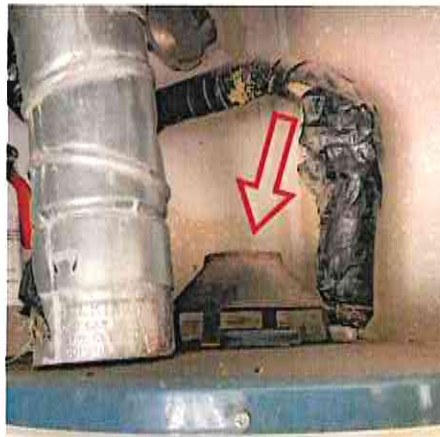
- Exhaust pipe wasn't installed properly, which may pose a safety hazard.

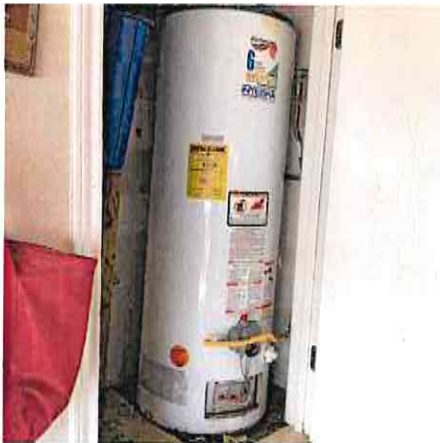
- Water heater wasn't level.

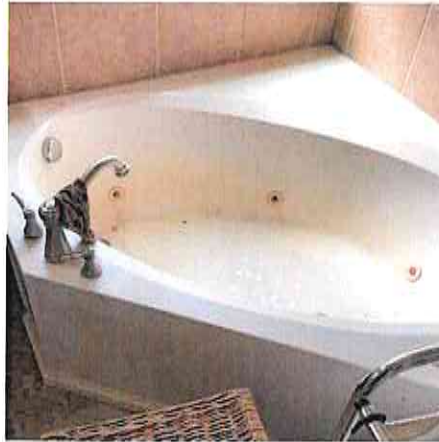
- Equipment didn't work properly.

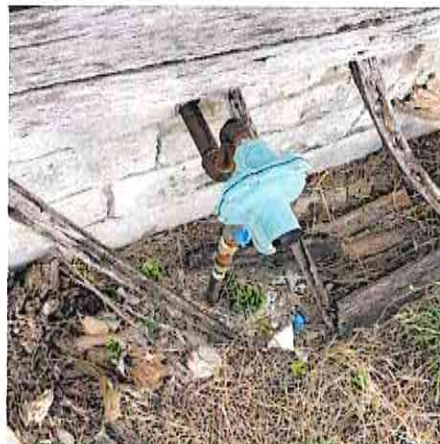
- The gas piping didn't appear to be properly bonded, which may pose a fire hazard. A bonding clamp wasn't observed.

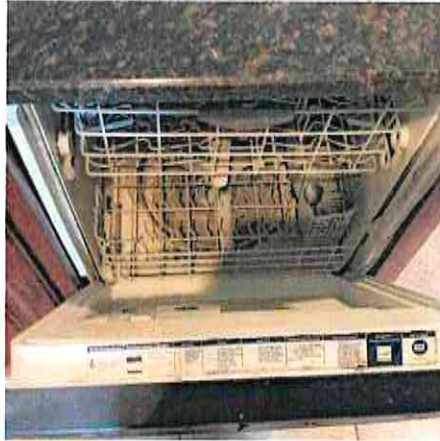
- The dishwasher was inoperable at the time of inspection.

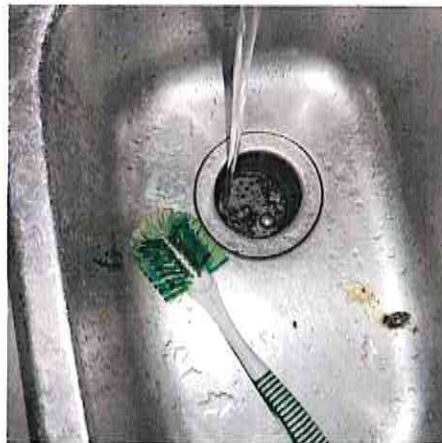
- Splash guard was missing.

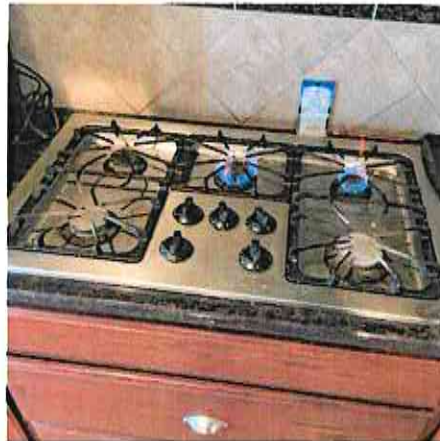
- Some burners didn't light.

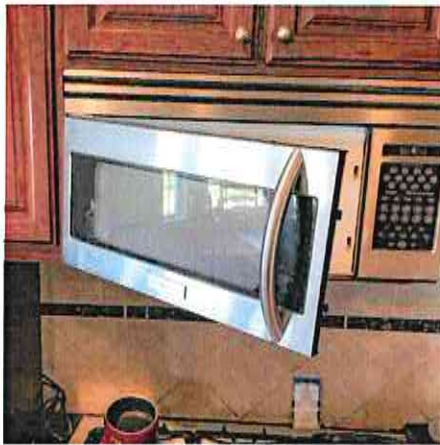
- Door was loose.

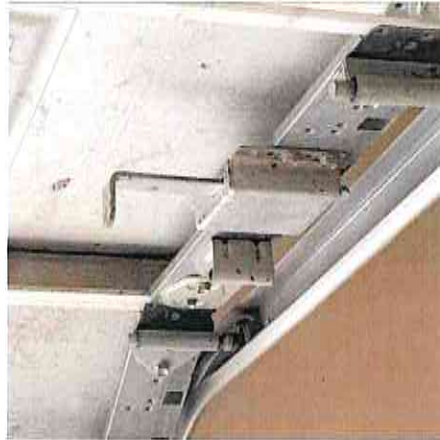
- The garage door manual locking device was not disabled. Lock is required to be disabled when an electric opener is installed. The opener motor is very strong and if the opener is operated with the manual lock engaged the whole mechanism could tear itself off the ceiling causing injury to persons and property.

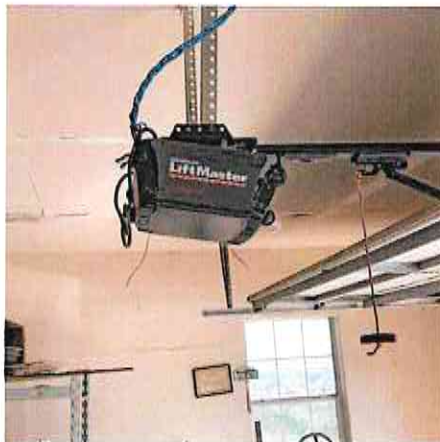
- The garage door operator didn't function at the time of inspection.
