Geologic Assessment

Regulated Entity Name: <u>Seargeant Tracts, FM 1626 at Cole Springs Road, Buda, Hays County,</u> <u>Texas</u>

ATTACHMENT C SITE-SPECIFIC GEOLOGY

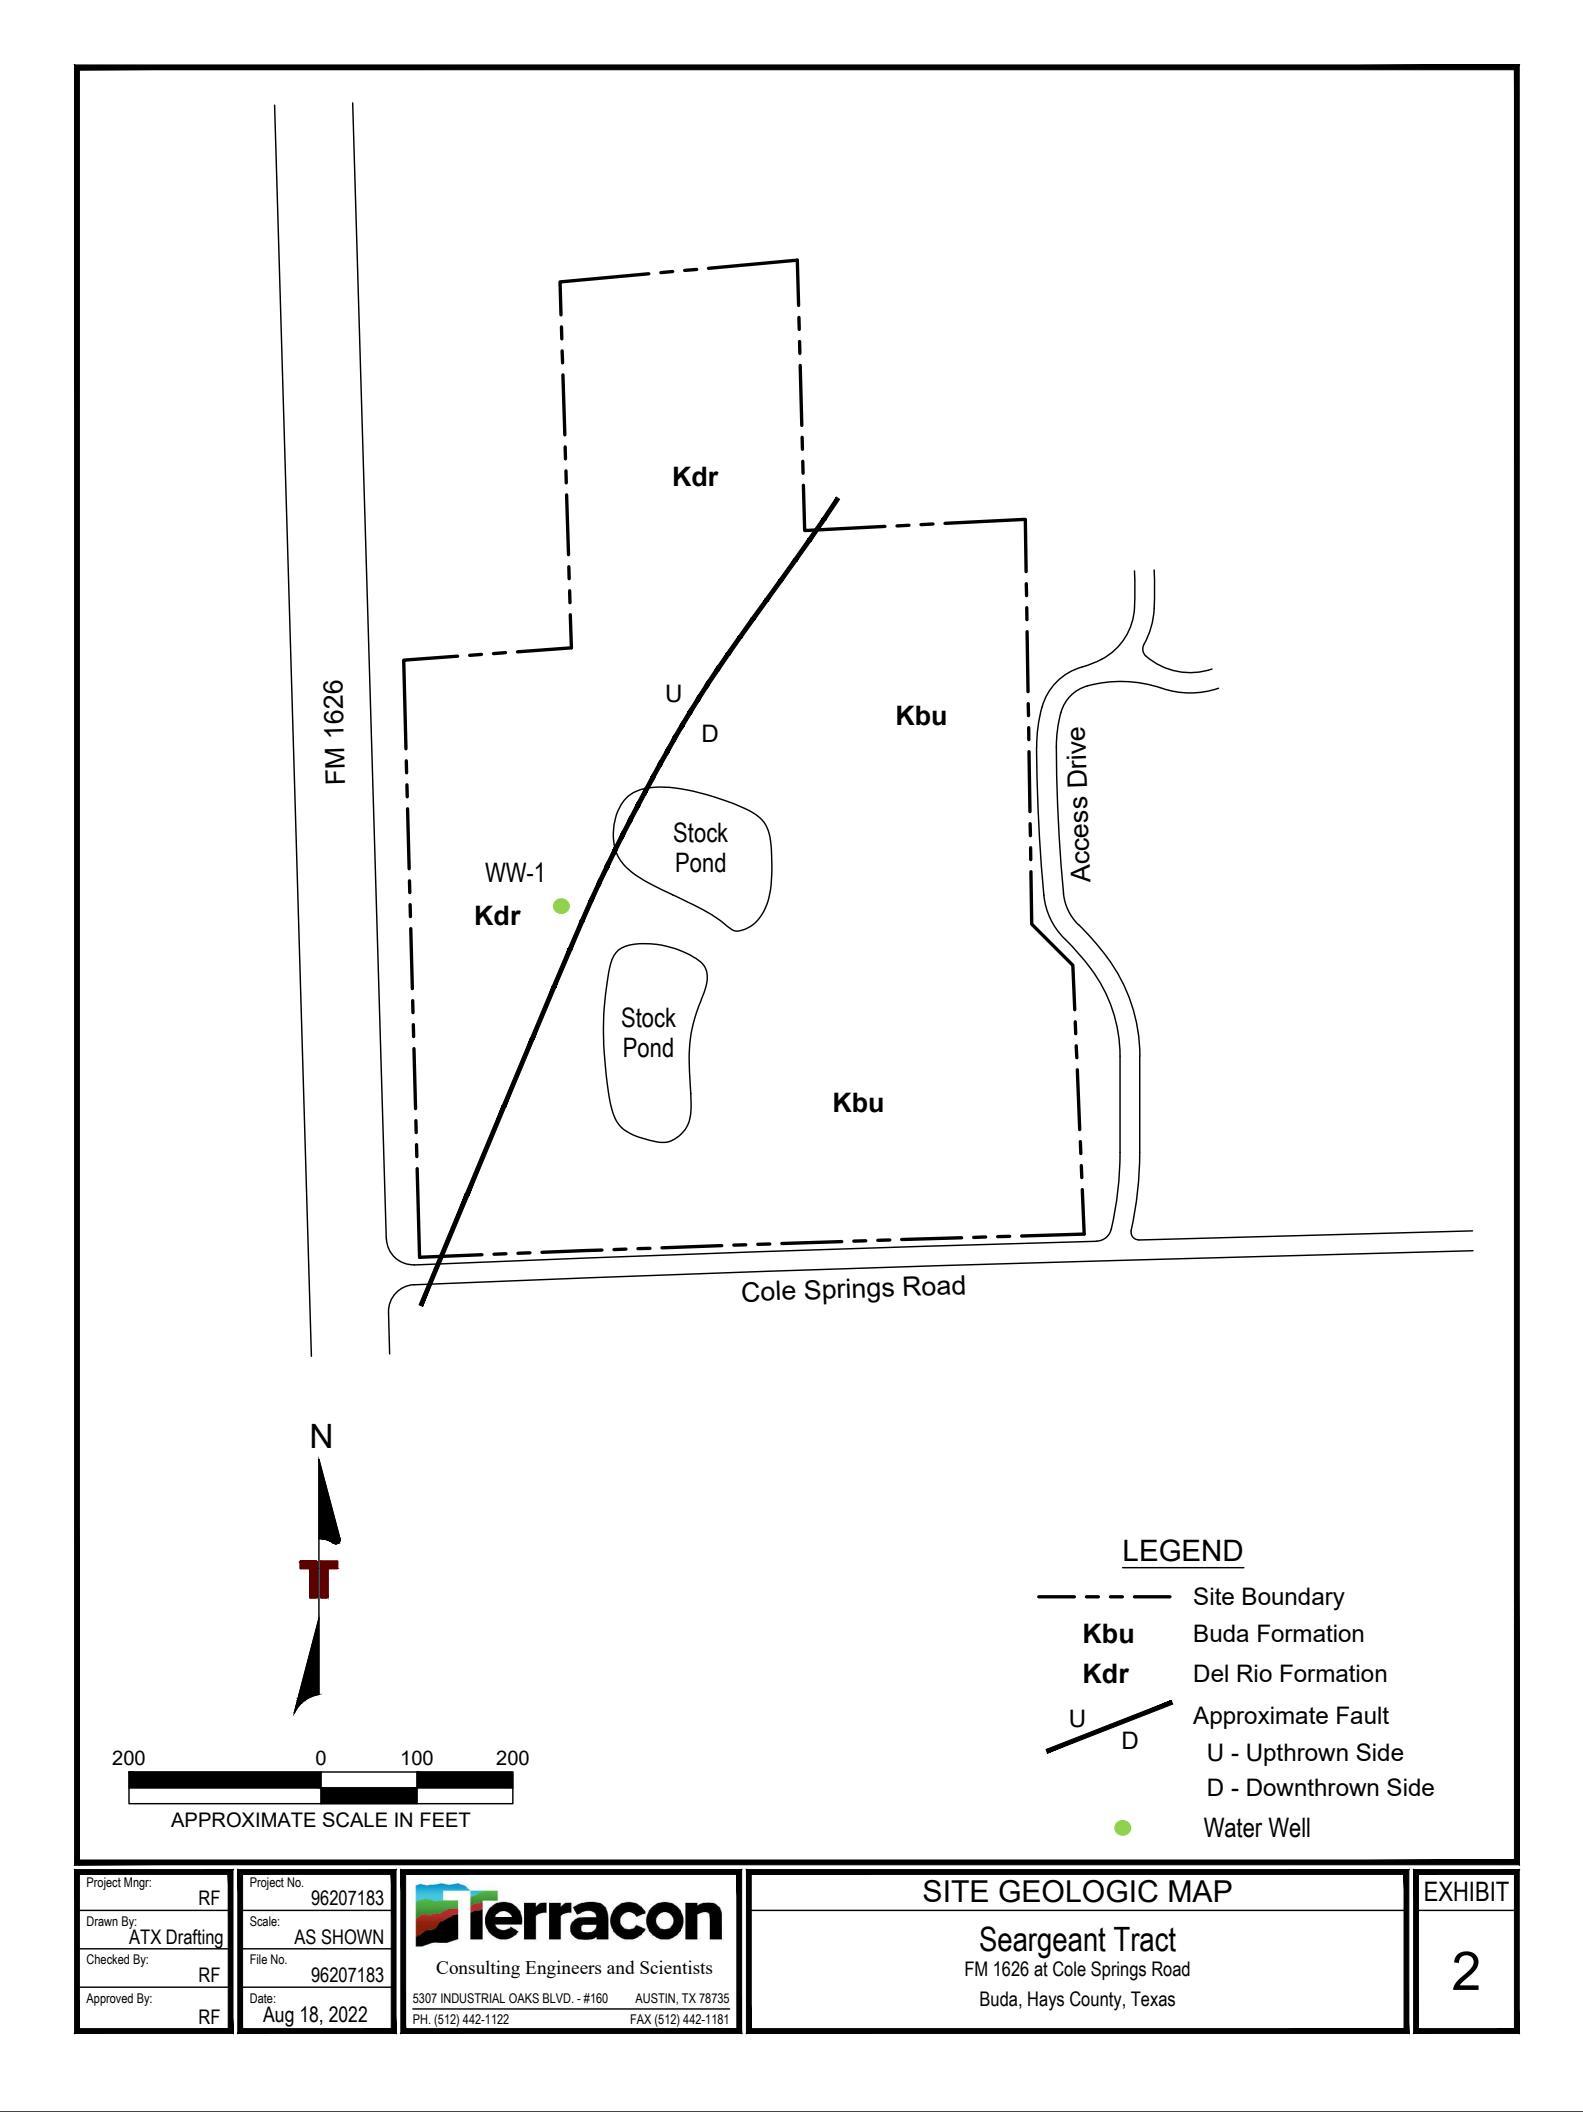
The Geologic Site Map is provided as Exhibit 2. The site is located entirely within the Recharge Zone of the Edwards aquifer. The recharge zone boundary is located approximately ½ mile east of the site. The surficial geologic units present at the site have been identified as the Buda Formation and the Del Rio Clay. Both units comprise part of the upper confining unit of the Edwards aquifer.

A review of aerial photographs did not reveal any lineations or faults and there was no surficial evidence of site faulting. However, a fault is mapped as crossing through the site as depicted on Exhibit 2. The fault, locally referred to as the Mustang Branch Fault, is associated with the Balcones Fault zone. The faults trend to the northeast and form the dominant structural trend in the area.

No geologic features, as defined in 30 TAC §213, were observed on the site. A water well is located behind the existing residence as shown on Exhibit 2. The well is located within a small well shed and is currently in use. Based upon the lack of any significant sensitive recharge features onsite, the potential for fluid flow through the site is considered low.
