SUPER INSPECTOR RESIDENTIAL INSPECTION*

400 Twin Oaks Trail
Dripping Springs TX 78620

PROPERTY INSPECTION REPORT

Concerning: 400 Twin Oaks Trail, Dripping Springs TX 78620

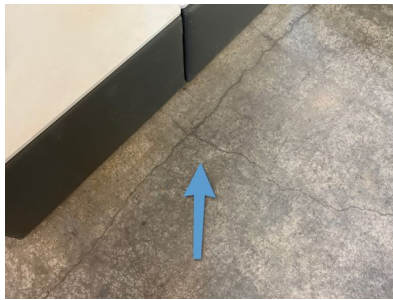
1: Slab - Common foundation cracks on exposed surfaces

Common cracks were observed in the exposed areas of the slab. This commonly occurs as the result of settling and/or surface checking. Surface checking occurs when concrete is poured in a dry state, which increases tensile strength. The dry state results in differential curing causing the surface areas to fracture. This is normal with concrete slabs. Cracks should be monitored for disjuncting and/or separations and evaluated if adverse conditions are observed.

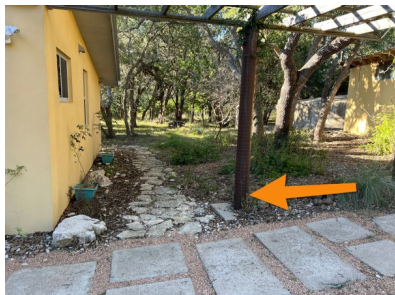
Grading is sloping towards the home in some areas. This could lead to water intrusion and foundation issues, these areas should be monitored and if water is not diverting around the structure it is recommended that a qualified landscaper or foundation contractor regrade so water flows away from home.

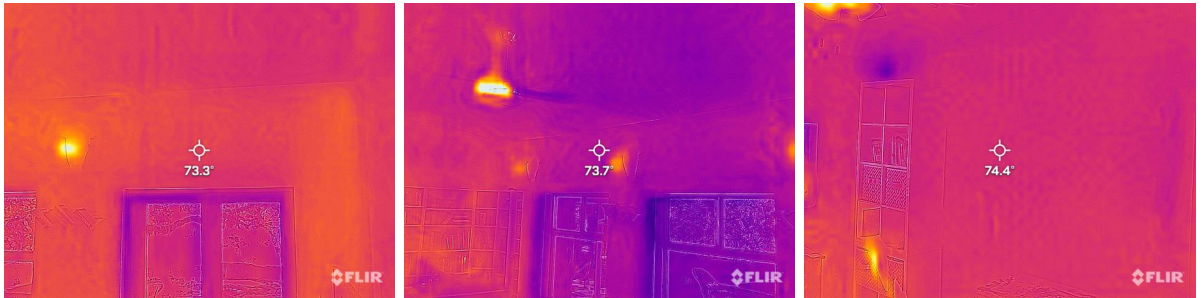
Photos - Interior Walls Thermal Image Samples:

The interior walls were scanned with a FLIR thermal imaging camera. Temperature variations can indicate missing insulation, trapped moisture, overheating conductors, or other defects. The thermal pictures below are a sample of random exterior walls in this house at the time of this inspection.

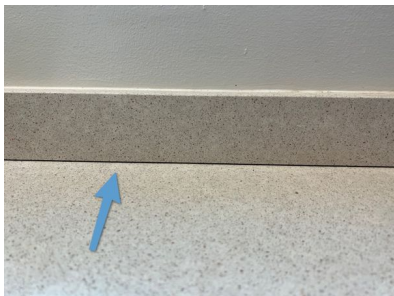
The counter top is not sealed to the backsplash. Sealant should be applied to prevent moisture penetration in this area.

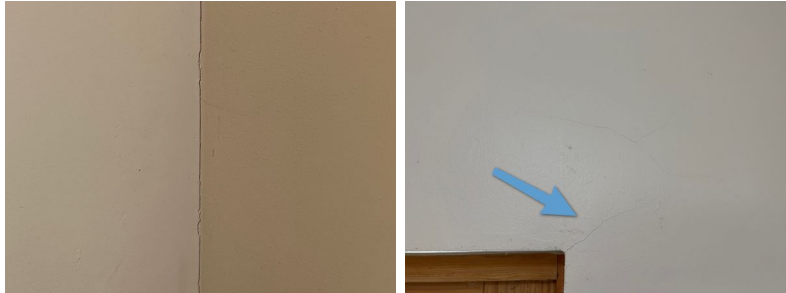
2: Interior walls - Common cracks

One or more common cracks were observed on the interior walls of the house. This may be due to normal settling and/or thermal movement of the building materials. These areas should be monitored for further signs of movement.

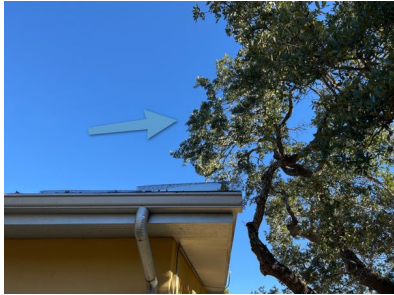
One more large branches are stretching over the roof of the house. If these branches were to fall they may damage the roof structure. The branches should be trimmed back to help prevent damage to the roof structure.

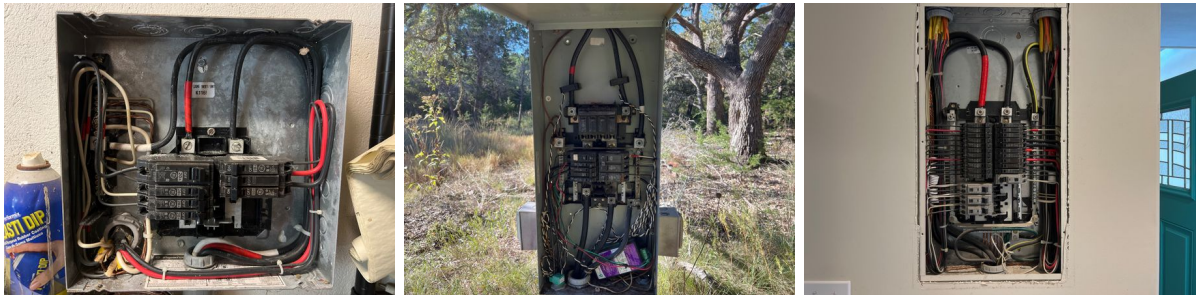
Photos - Electrical panels uncovered for inspection:

This inspection covers the service entrance wiring, electrical panels and subpanels.

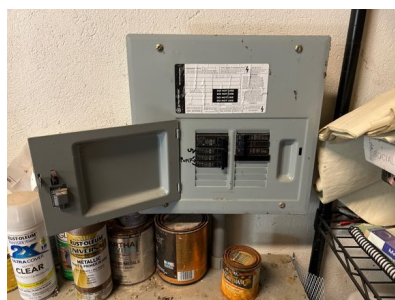
1: Panel not labeled

The breakers in the panel are not properly labeled. The breakers should be individually labeled for identification purposes.

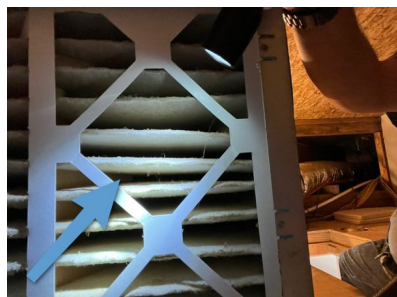
The air filter is dirty/missing. Replacement is recommended.

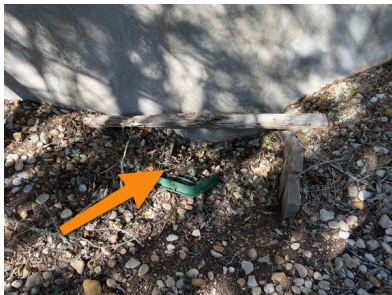
The homeowner shut off/water meter is buried in the valve box. Recommend cleaning out the valve box for ease of access.

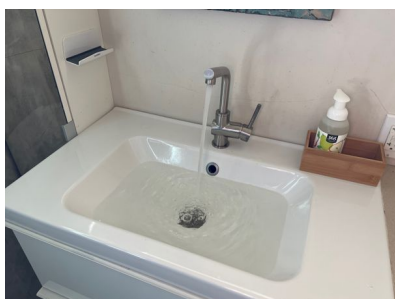
Note: A drain load test was performed by filling all available sinks, bathtubs, and shower pans to a high level. **Note: upper-level tub overflow drains are not tested due to the risk of damage to private property.**

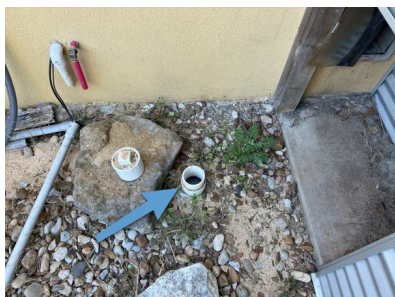
There is a missing/damaged cleanout cap. The cap should be replaced to help keep debris out of the waste lines and to help prevent sewer gases from escaping from the drain cleanouts.

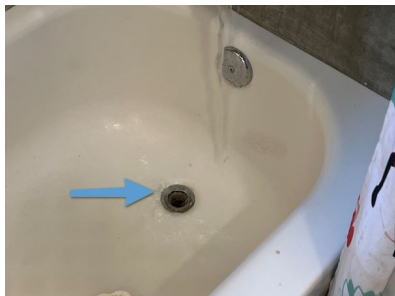
2: Missing stopper

The drain stopper is missing or non-functional at one or more sinks or tubs. Repair and/or replace as necessary.

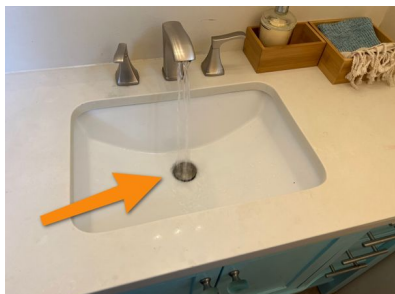
3: Stopper did not function

One or more drain stoppers did not function properly. Further evaluation and repair is advised.

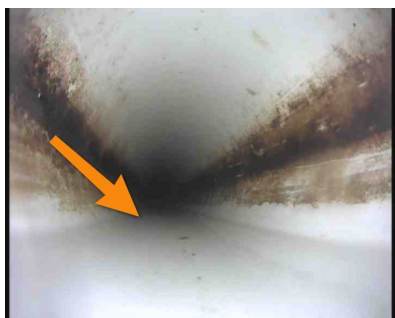
4: Sewer Camera - Belly in Pipe

There appears to be a belly in the drain line. A belly in the pipe means there is a low spot holding water. Bellies can accumulate debris and cause clogging of the pipes due to poor drainage.

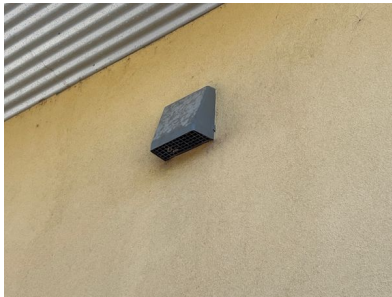
Photo - Exhaust Termination:

Range Exhaust: vents to the exterior

1: Range hood Inoperable

🚫 **Further Evaluation Required**

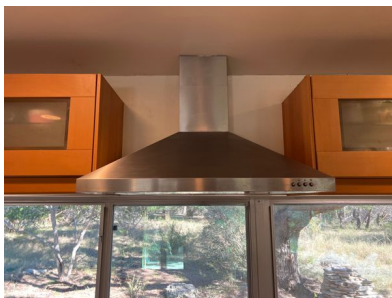
The fan was inoperable. Recommend a qualified contractor for repair.

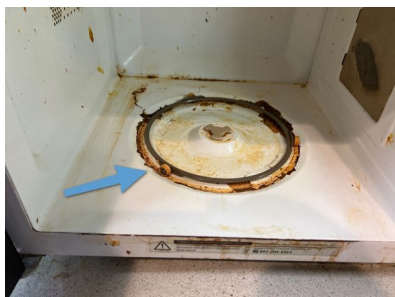
1: Rust in microwave

Rust was observed in the back of the microwave. The cavity of the microwave oven is outfitted with metal and covered by a paint. The metal bounces the microwaves inside the oven to heat the food. Rusted parts on the interior will still bounce the waves, but the longer the rust has a presence, the more it can grow. Once the paint inside the oven cavity begins to chip, oxygen bonds with the metal to form rust. Once rust forms, it weakens the metal and breaks it down. This can lead to microwaves leaking from the cabinet. Rust at the door seal is the most vulnerable place for leaks to occur. The surface can be repaired with proper preparation and specialized enamel paint. Further evaluation and/or repair if needed.

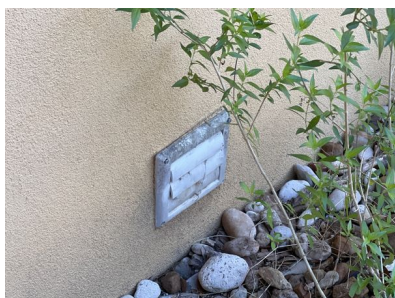
Photo - Vent Termination:

Dryer Vents: : Through Side Wall

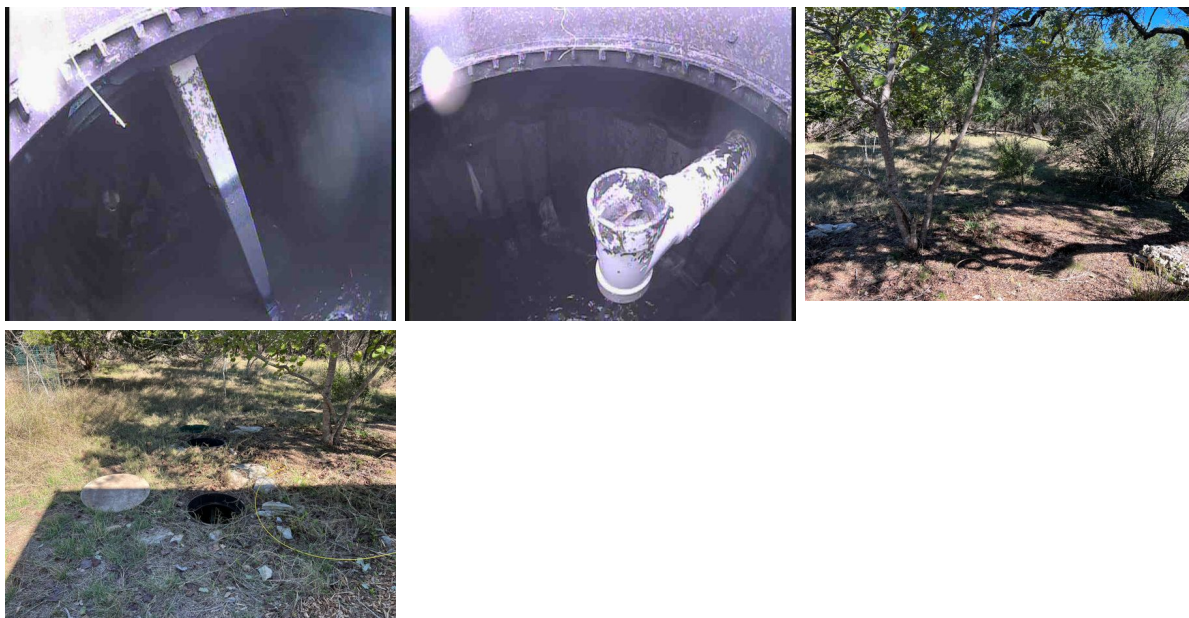
Photos - Panel, Tanks, Drain Field:

Type of System: Conventional Septic Tank (Anaerobic)

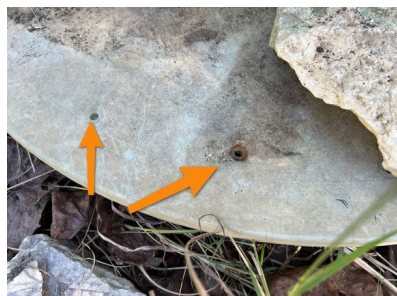
Fastener are missing in the septic riser covers. This may allow unauthorized access to the septic tanks. All screw openings and the safety screw should have stainless steel fasteners installed.
